# Manhole Inspection Summary

Manhole # S47K2\_004MH

Insp Date: **1/16/08 1:33 PM**

**Location** Address: **Ceddox-benhill Alley**

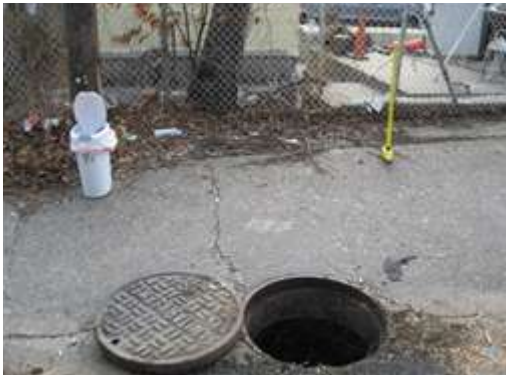
Location View

Ceddox-Benhill Alley

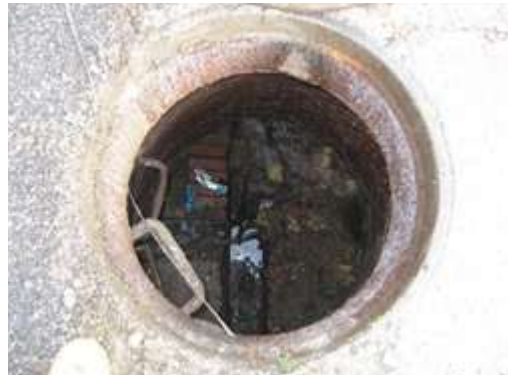
Top View

steps

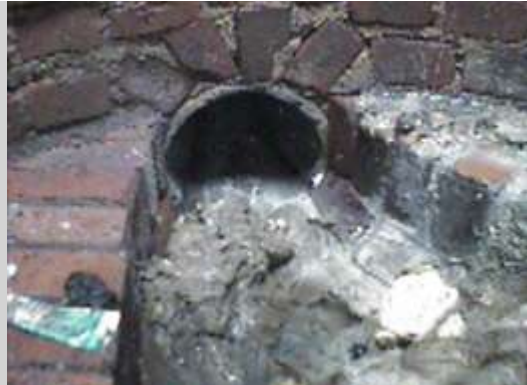
12 O'Clock Outflow

8 in. Circular Gravity Sewer  
Pipe Out @ 12 O'Clock

Pipe Height: **8.4** (in.) Rod and Bar (Angled)  
Pipe Material: **Clay** ☐ Pipe Lined  
Invert Depth: **6.72** (ft.) Flow Characteristics: **None**  
Deposits: ☒ None ☐ Mud ☐ Sludge ☐ Debris ☐ Grease  
Silt Depth: (in.) Deposits Extent:  
Infiltration: **None** Pipe Seal Cond: **Sound**

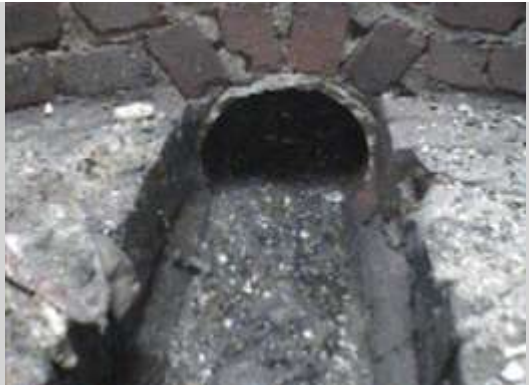
6 O'Clock Inflow

8 in. Circular Gravity Sewer

Pipe In @ 6 O'Clock

Pipe Height: **7.2** (in.) Rod and Bar (Angled)

Pipe Material: **Clay** ☐ Pipe Lined

Infiltration: **None** Pipe Seal Cond: **Sound**
